# The 2024 Noto Peninsula Earthquake

## - Liquefaction and lateral flow damage -

Hirofumi TOYOTA

Department of Civil and Environmental Engineering  
Nagaoka University of Technology

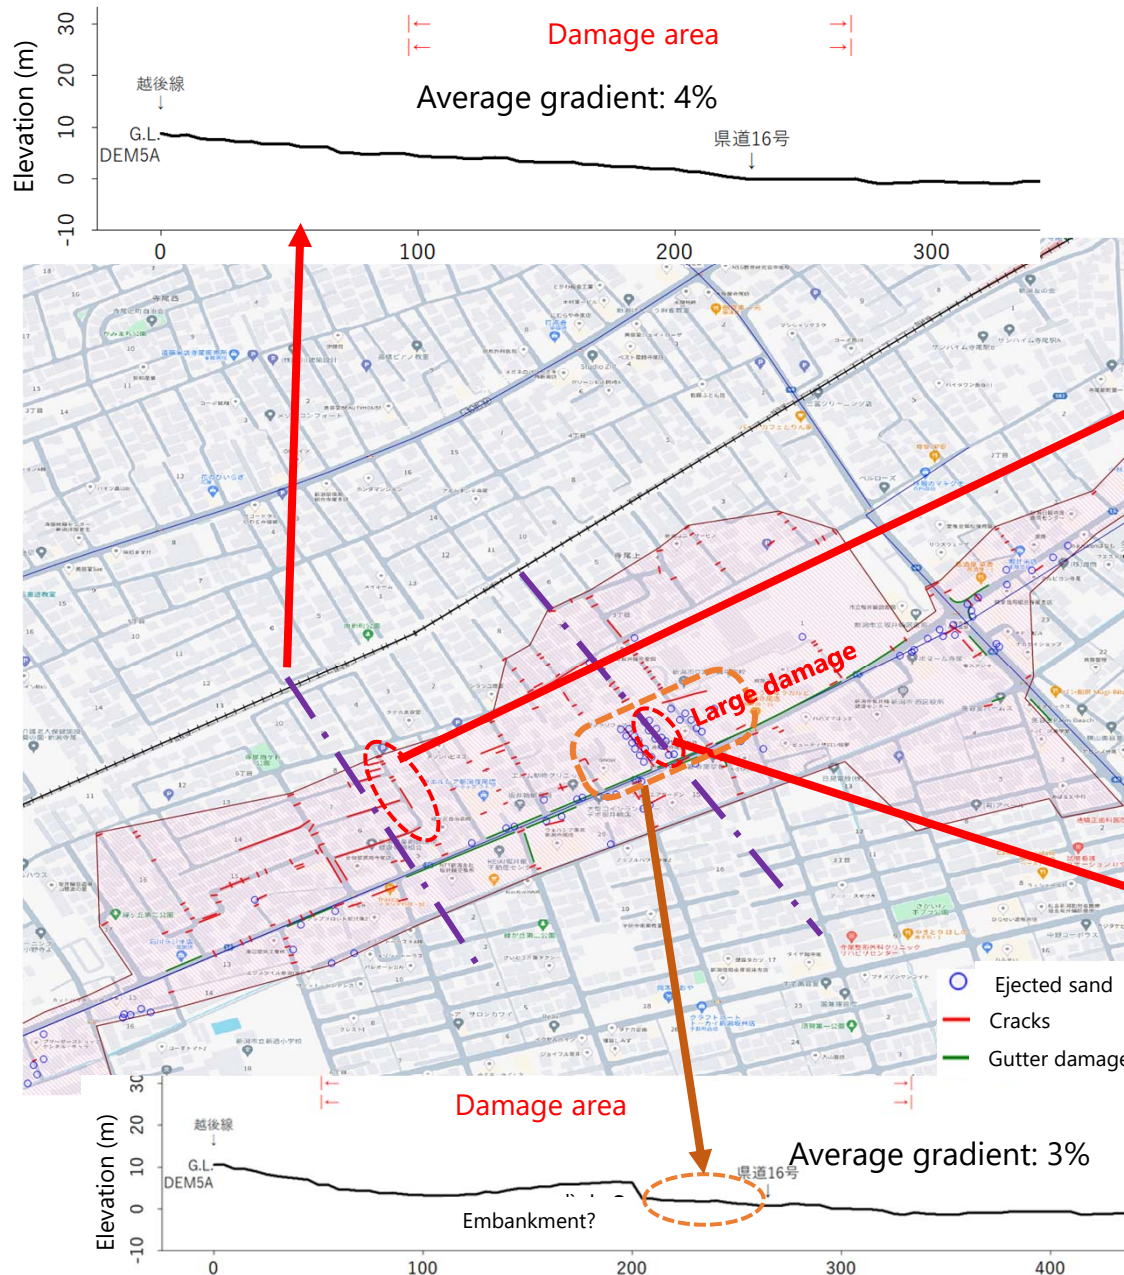
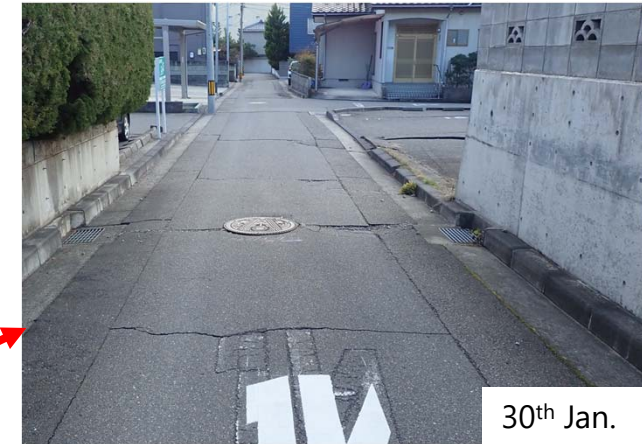
## Damage in Sakai area

Upper part of the slope: Open cracks

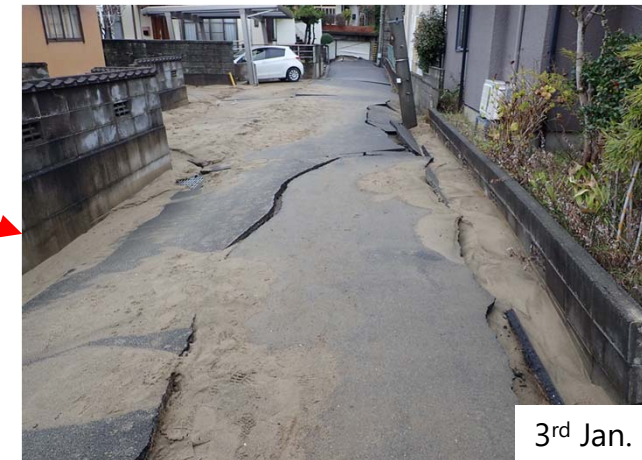
Lower part of the slope: Ejected sand and uplift of sidewalk

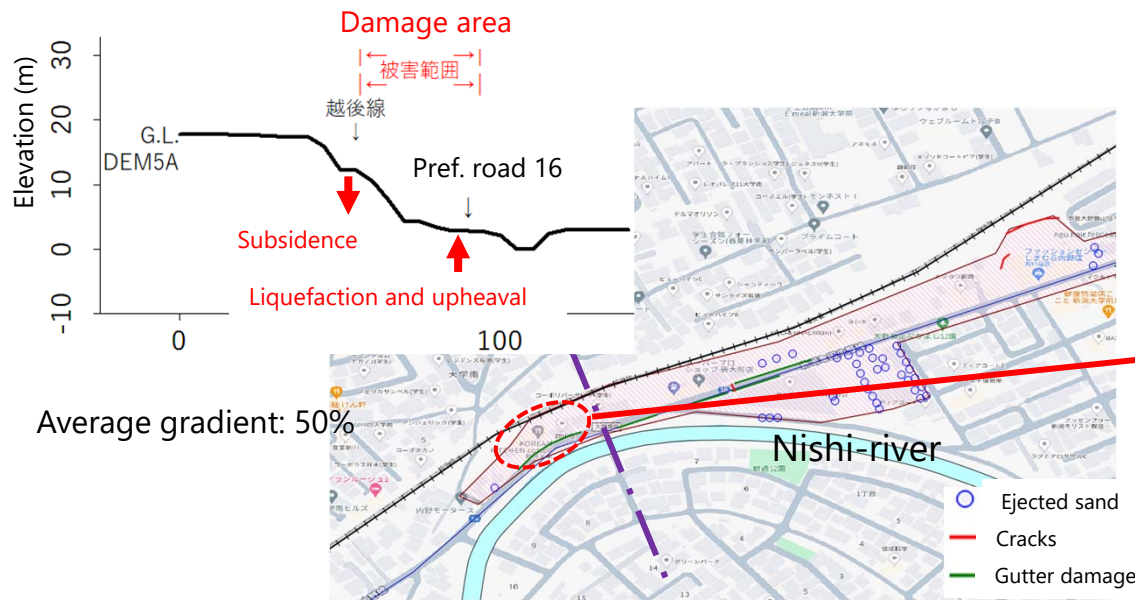
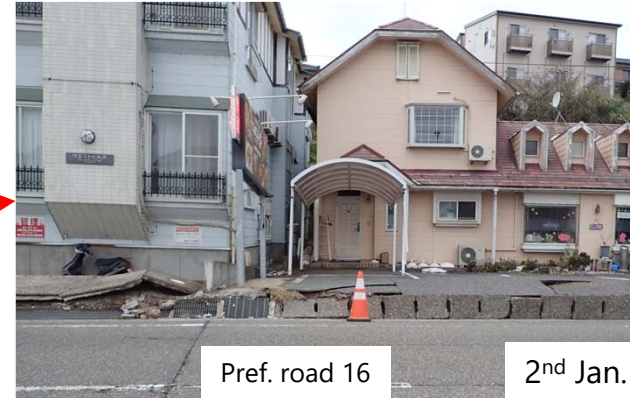
## Damage in Ohno area

Average gradient: 50%

Deformation of the road is slight

Large flow and subsidence

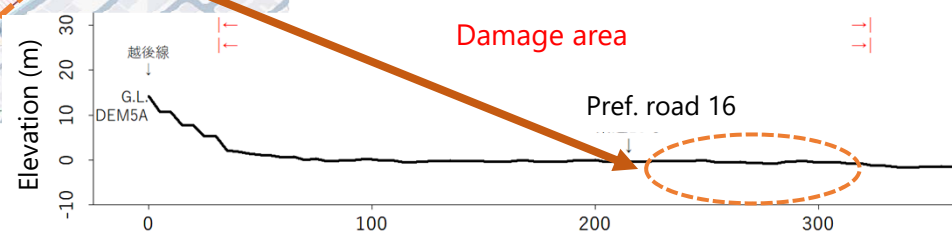
## Damage in Terao area

Average gradient: 0.5%

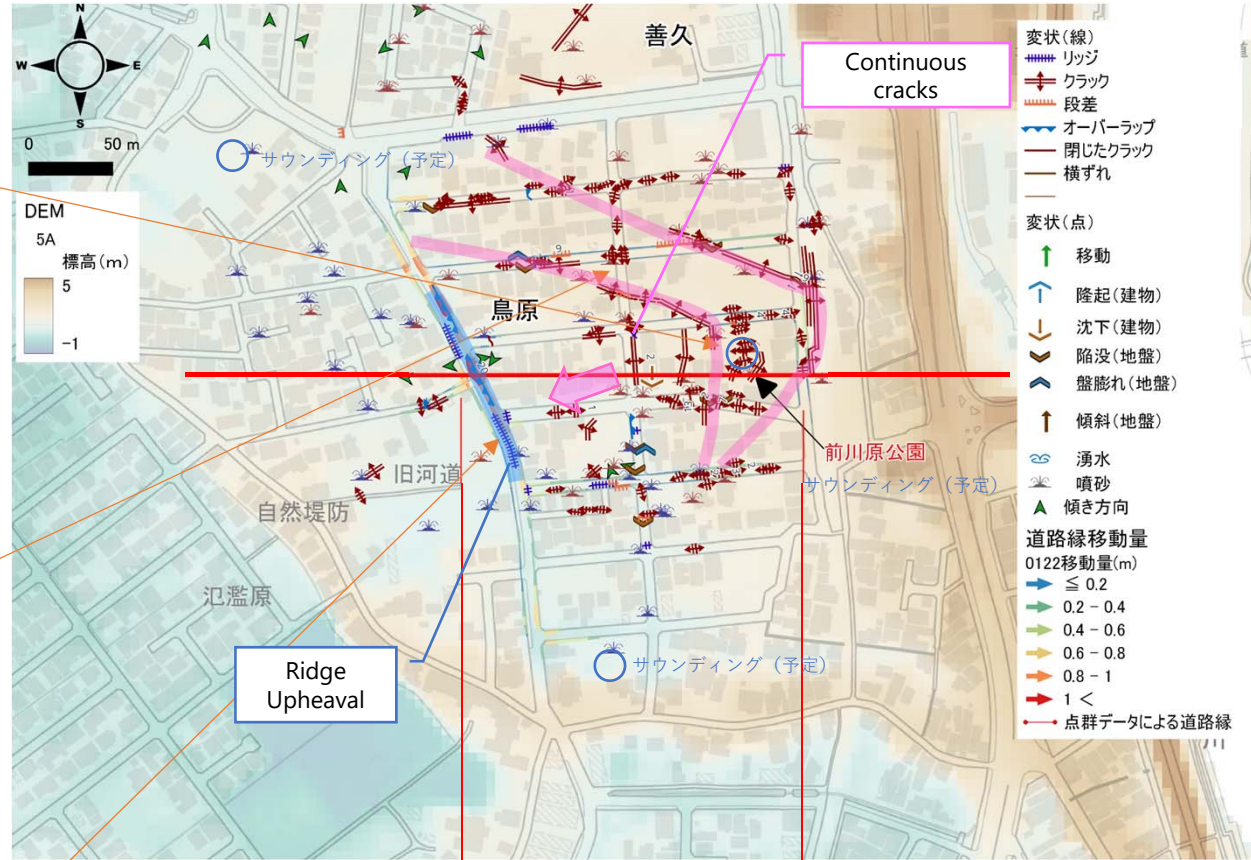
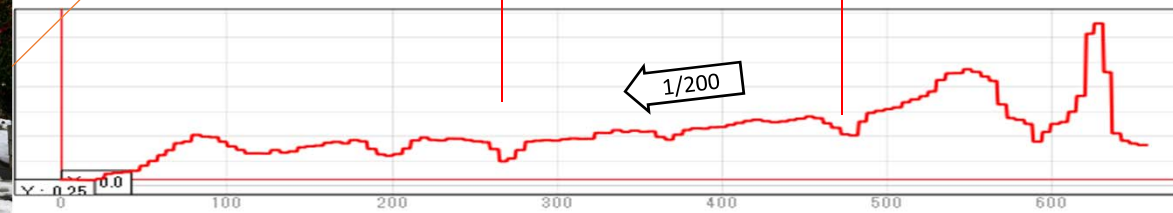
# Liquefaction in Toppara (Old river)

Lateral flow occurred in very gentle slope (1/200)

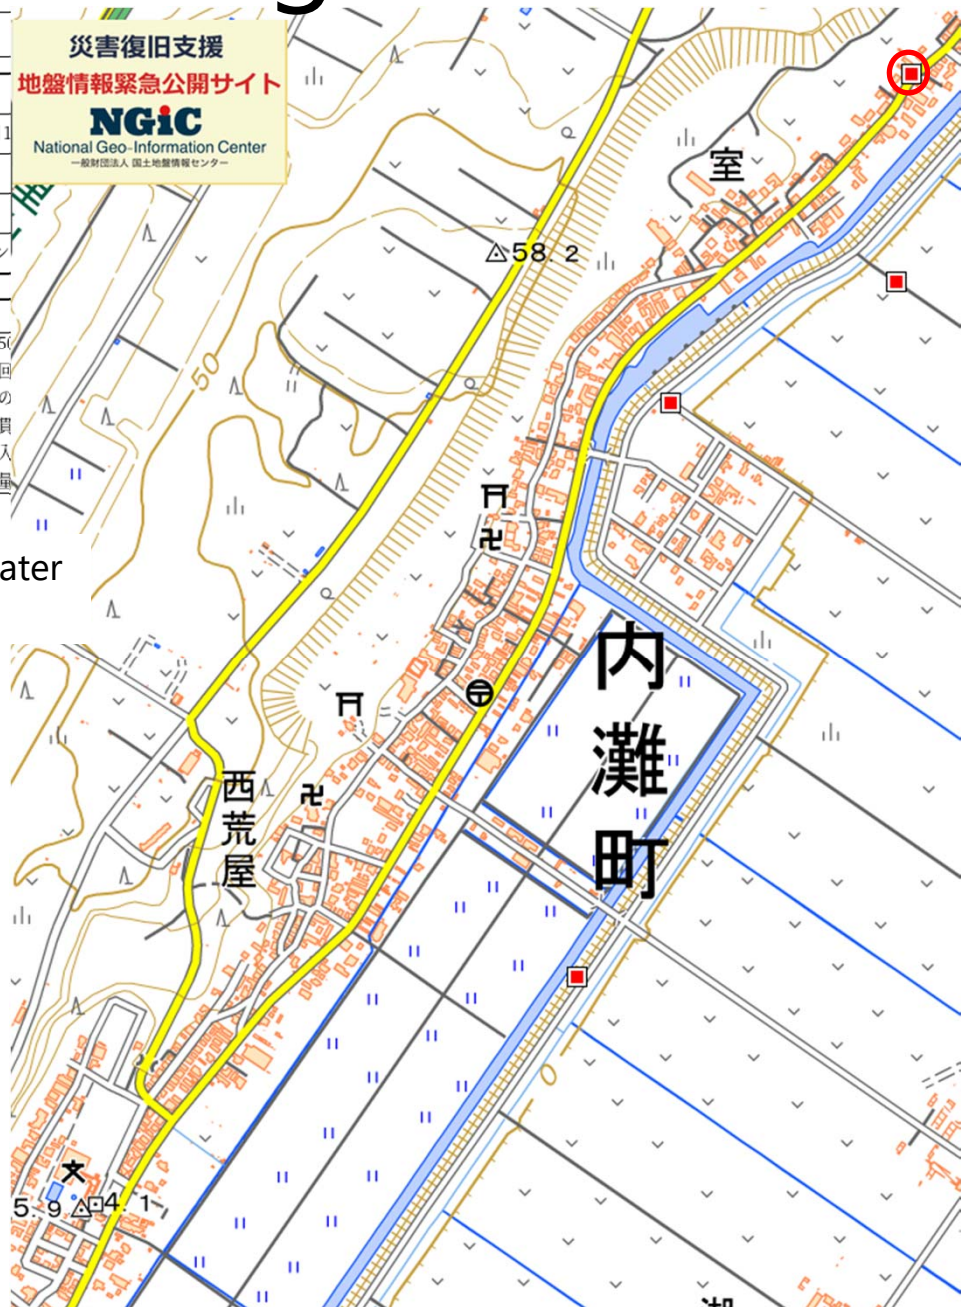
# Boring data

Fine sand

Shallow groundwater  
Small SPT-N

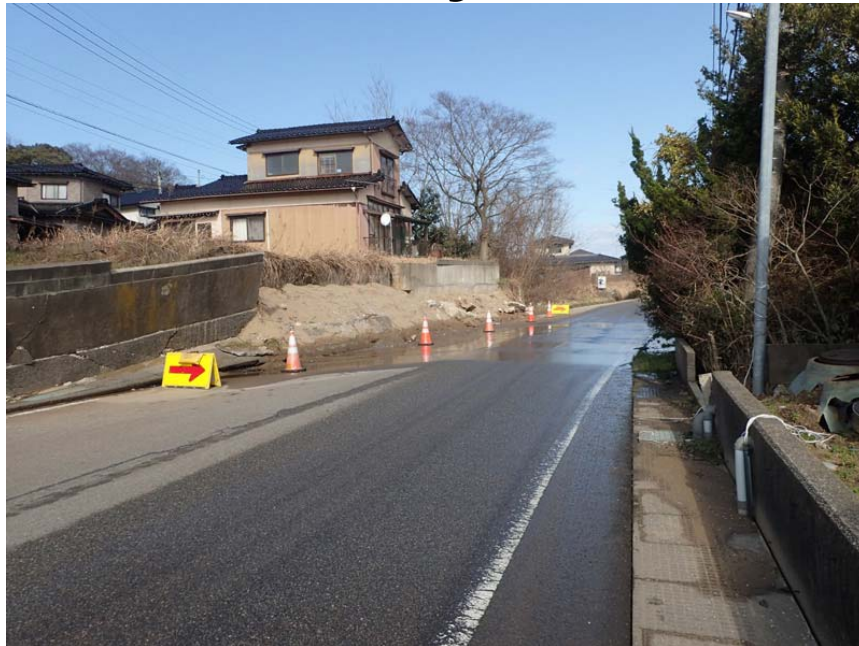
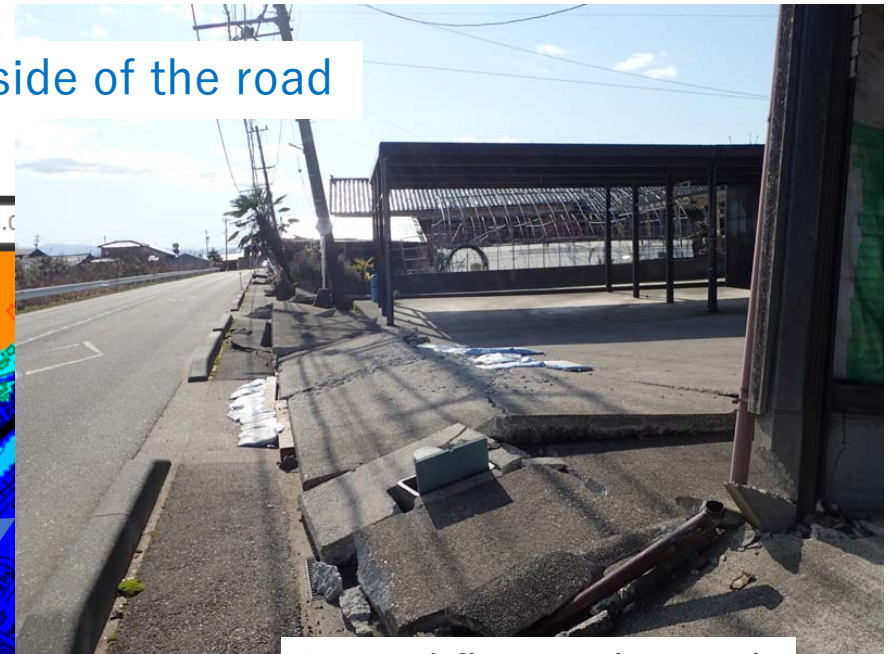
# Nishiaraya

Damage in dune side of the road

Lateral flow to the road

Spring water: high groundwater

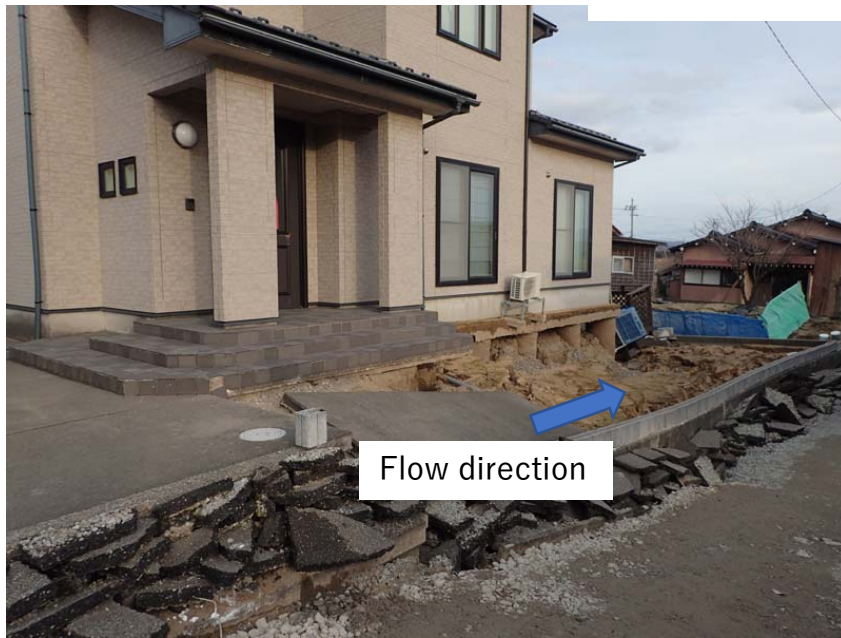
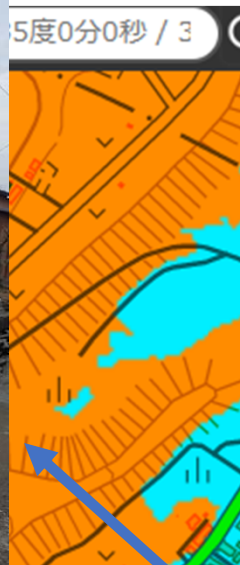
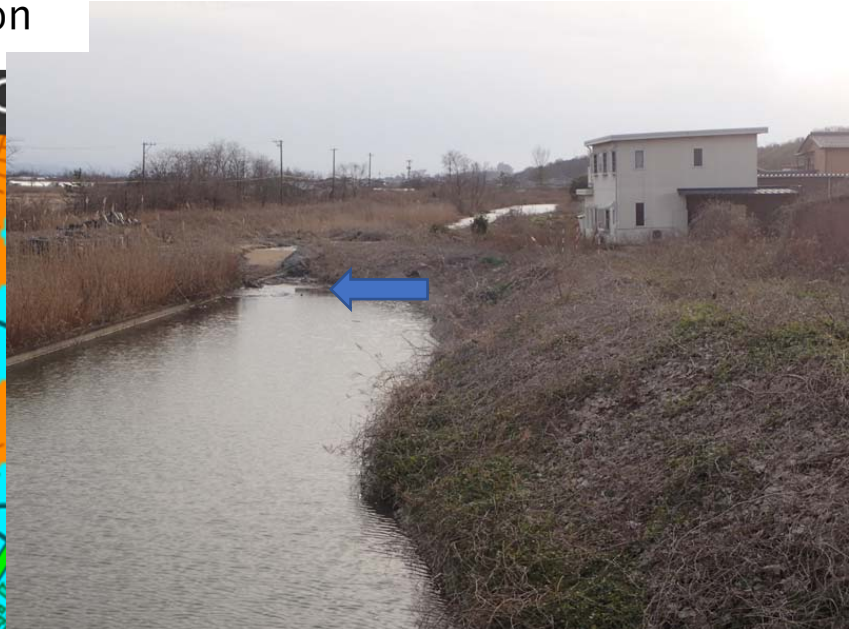
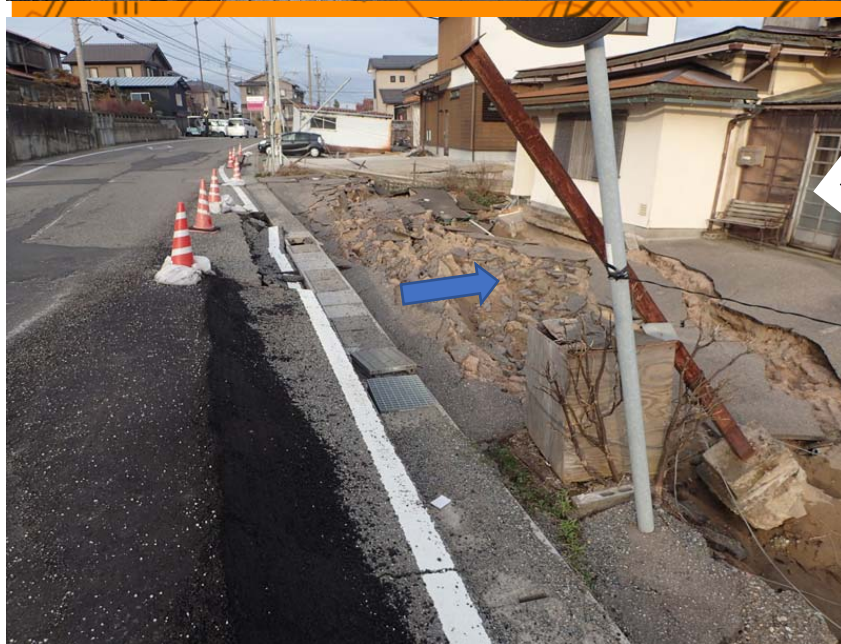
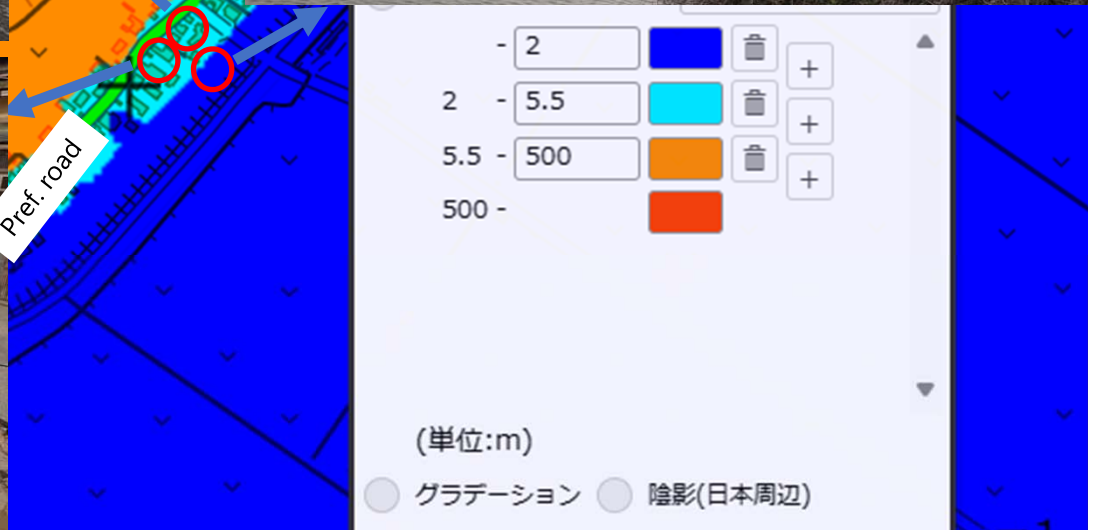
# Muro

## Damage in lagoon side of the road

Lateral flow to the lagoon

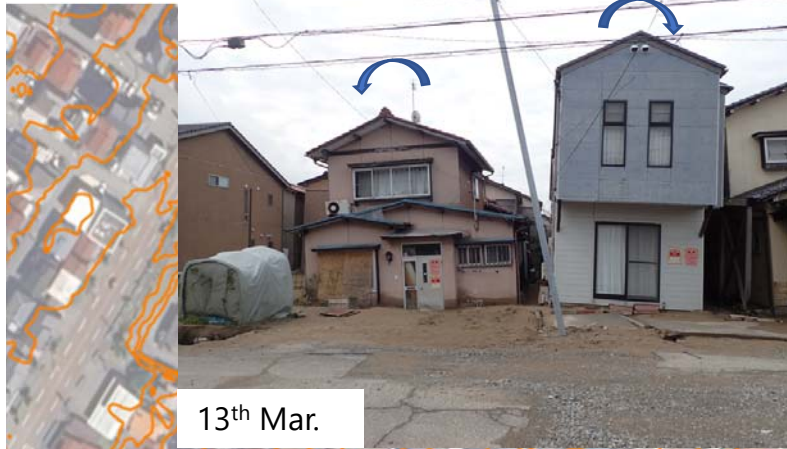
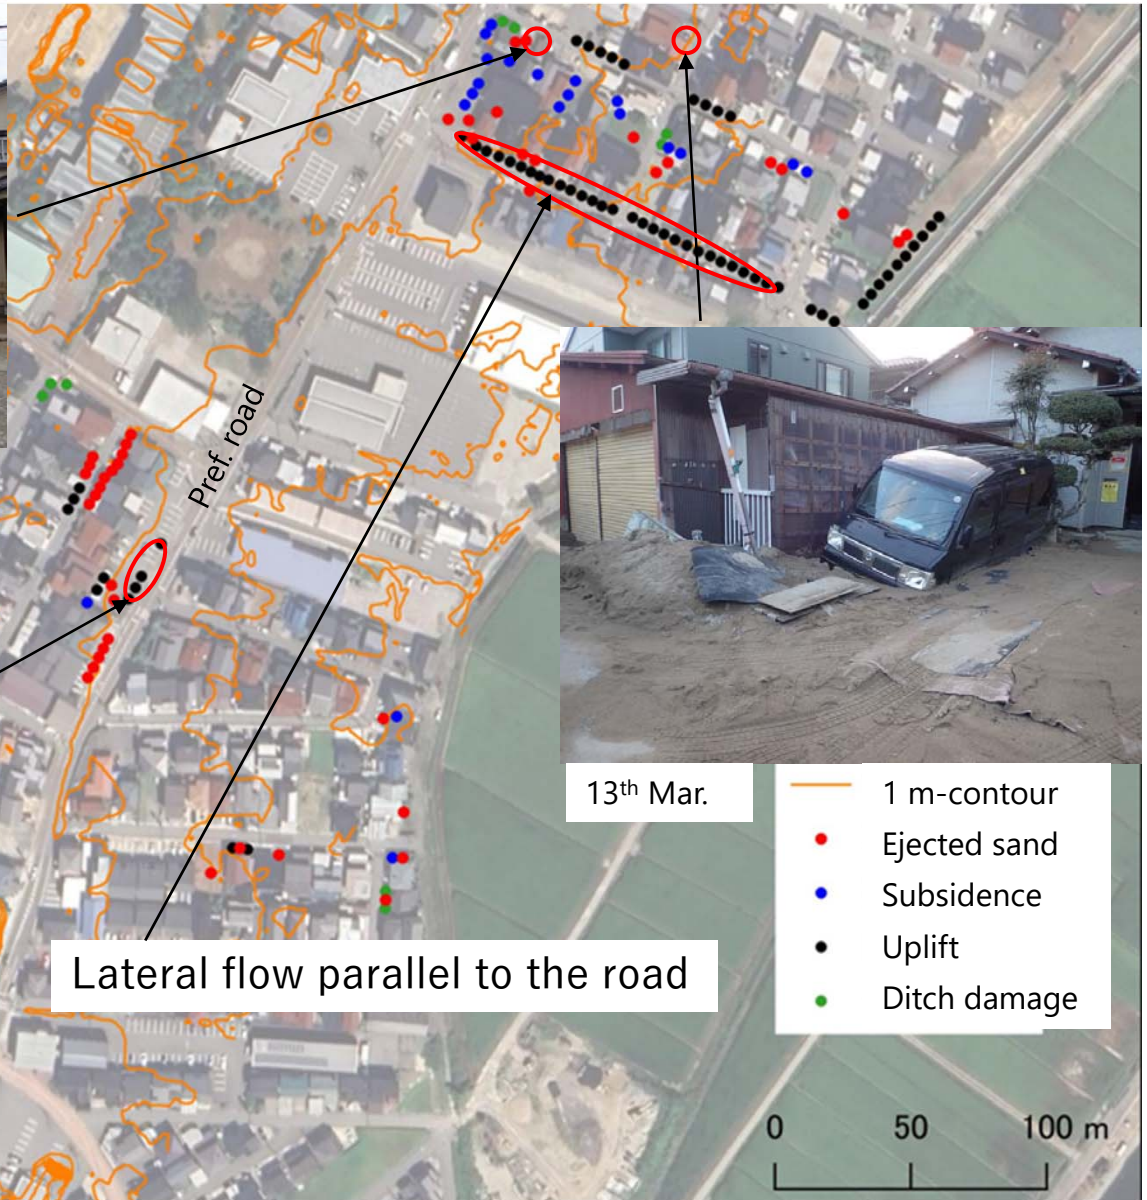
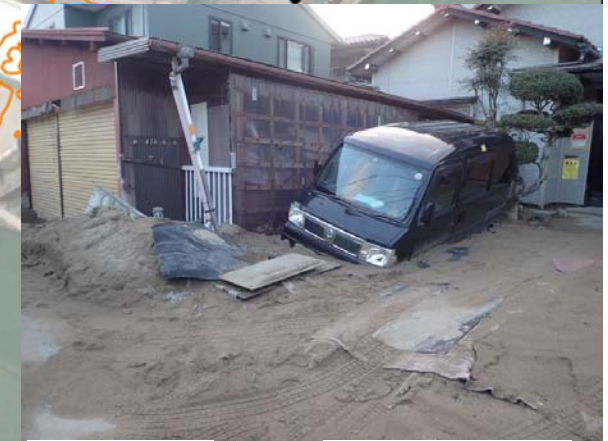
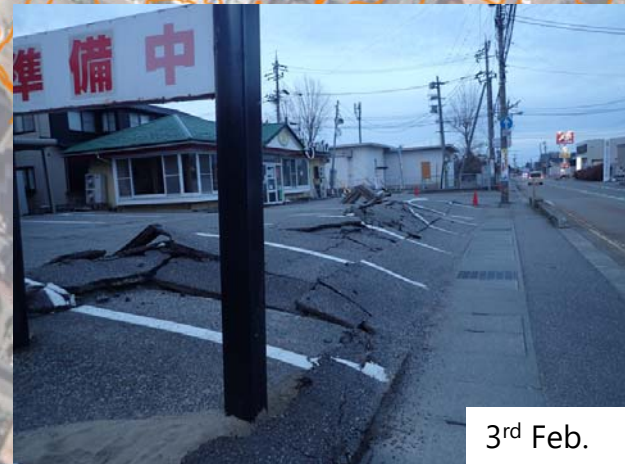
# Tsurugaoka

Serious liquefaction damage

Lateral flow to the road

Lateral flow parallel to the road

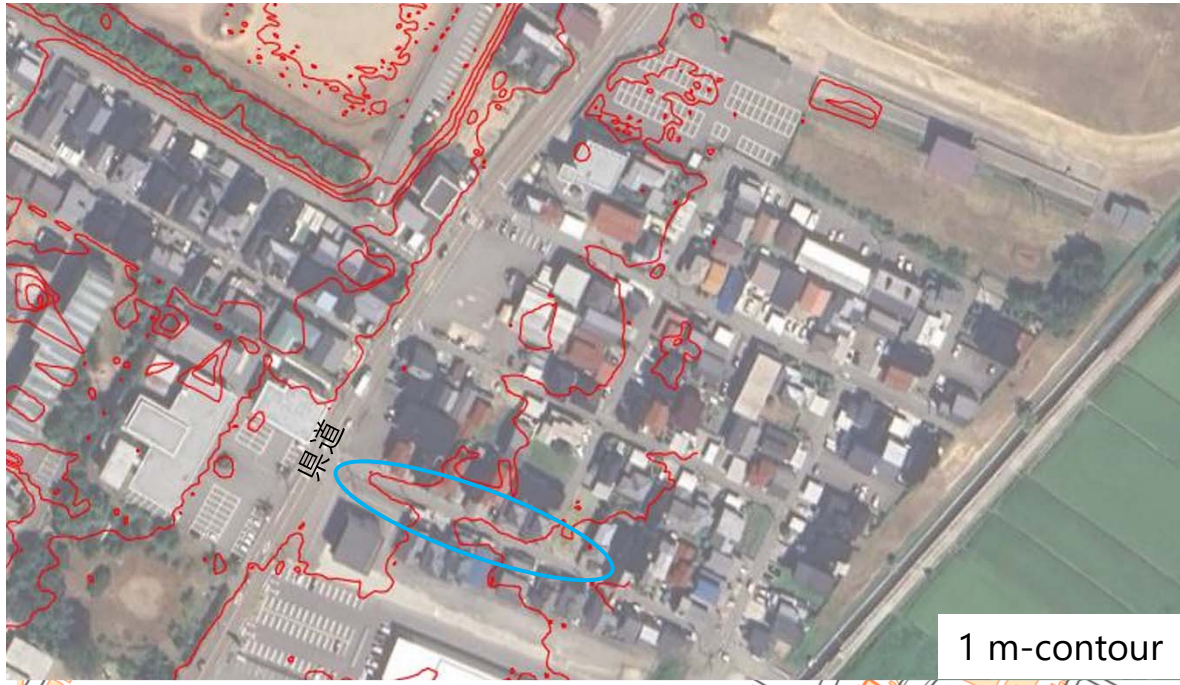
# Tsurugaoka

The contour falls into the road

Ave. gradient: about 1.3%

Ave. gradient: about 2%

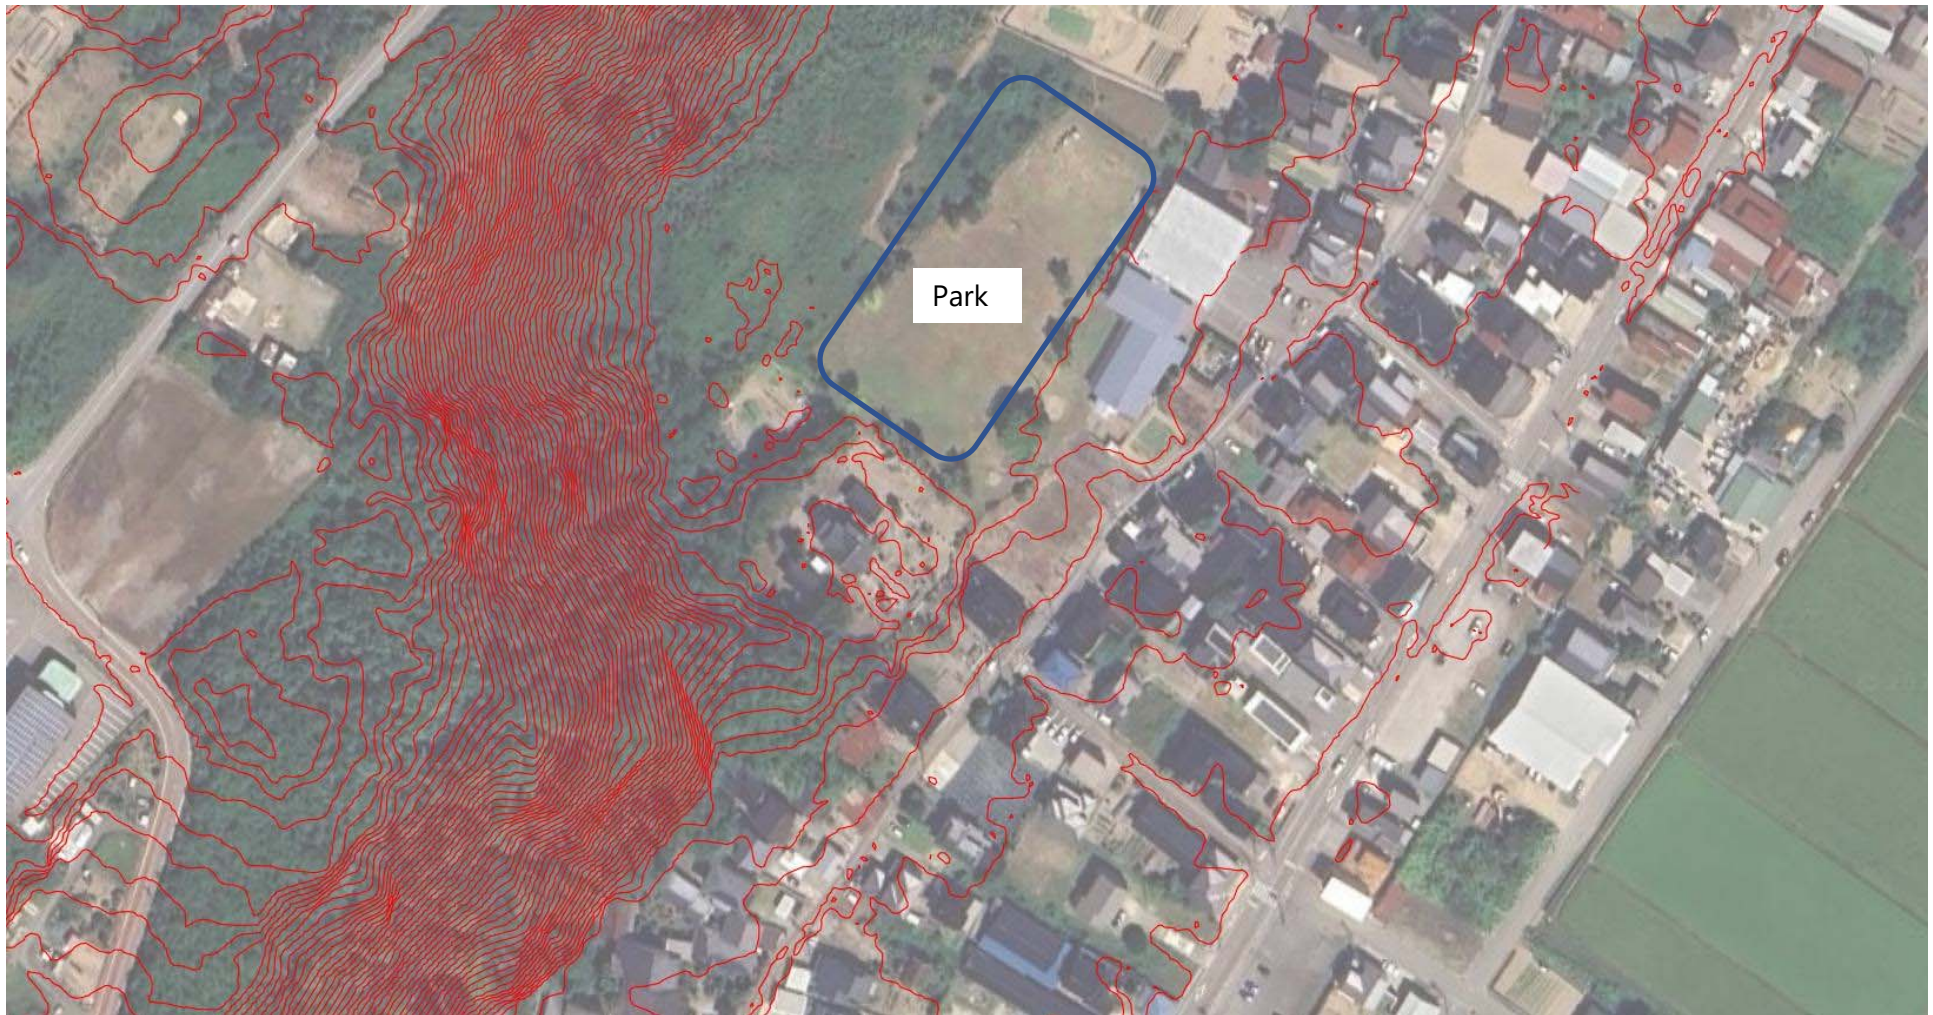
# Nishiaraya

The park was almost flat before the earthquake.

As a next step, amount of lateral flow should be measured quantitatively.

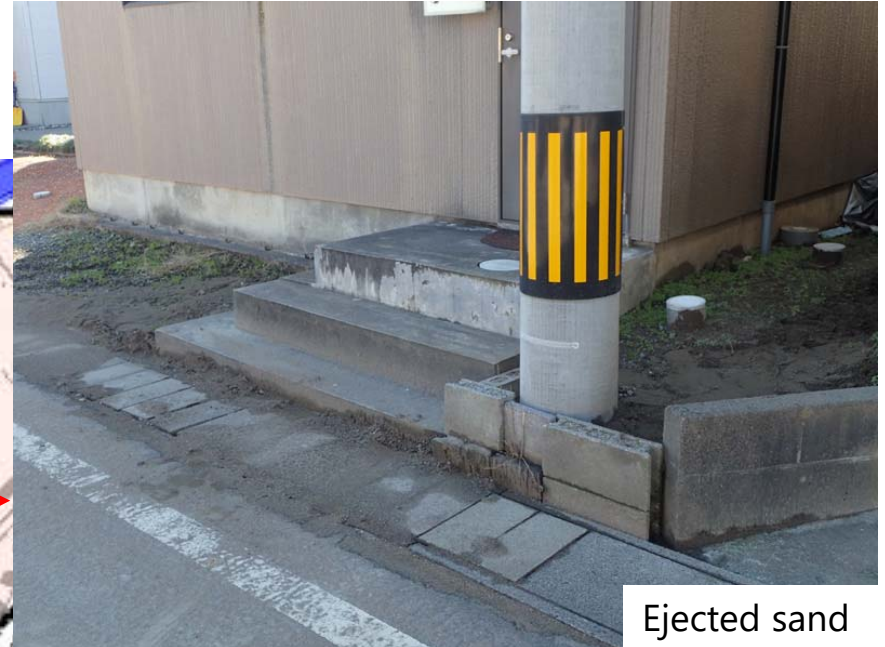
Ejected sand

Testimony: Sand was removed. A lot of water sprang out from the ground.

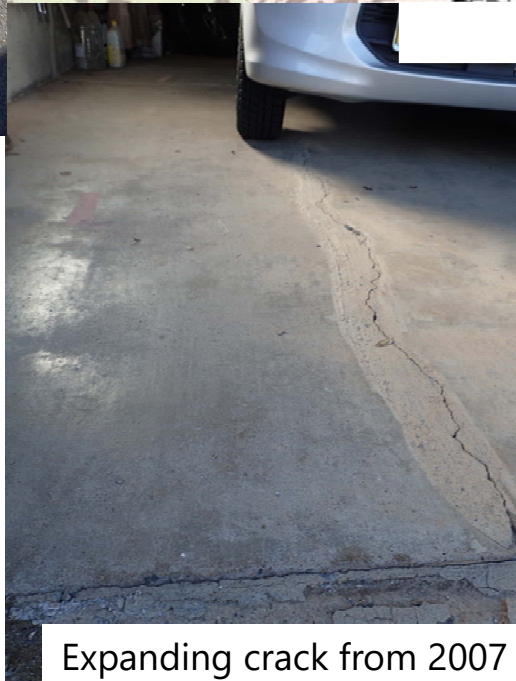
This place was liquefied at the 2004 Chuetsu and the 2007 Off Chuetsu Earthquakes

Expanding crack from 2007

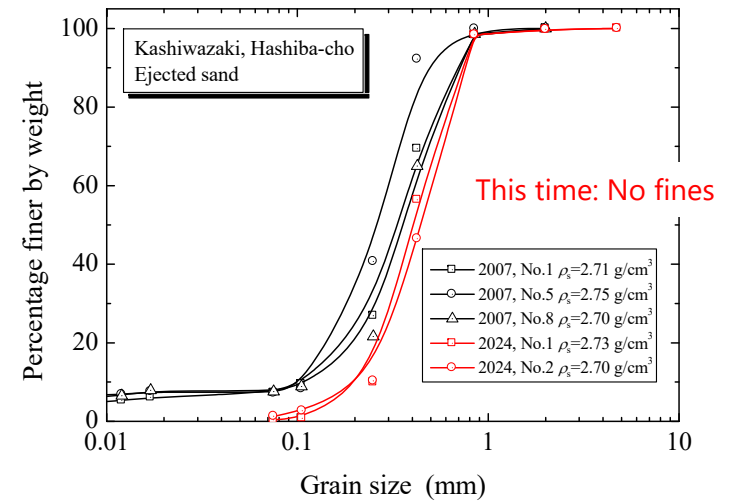
Liquefaction scale was small: Only surface was liquefied.

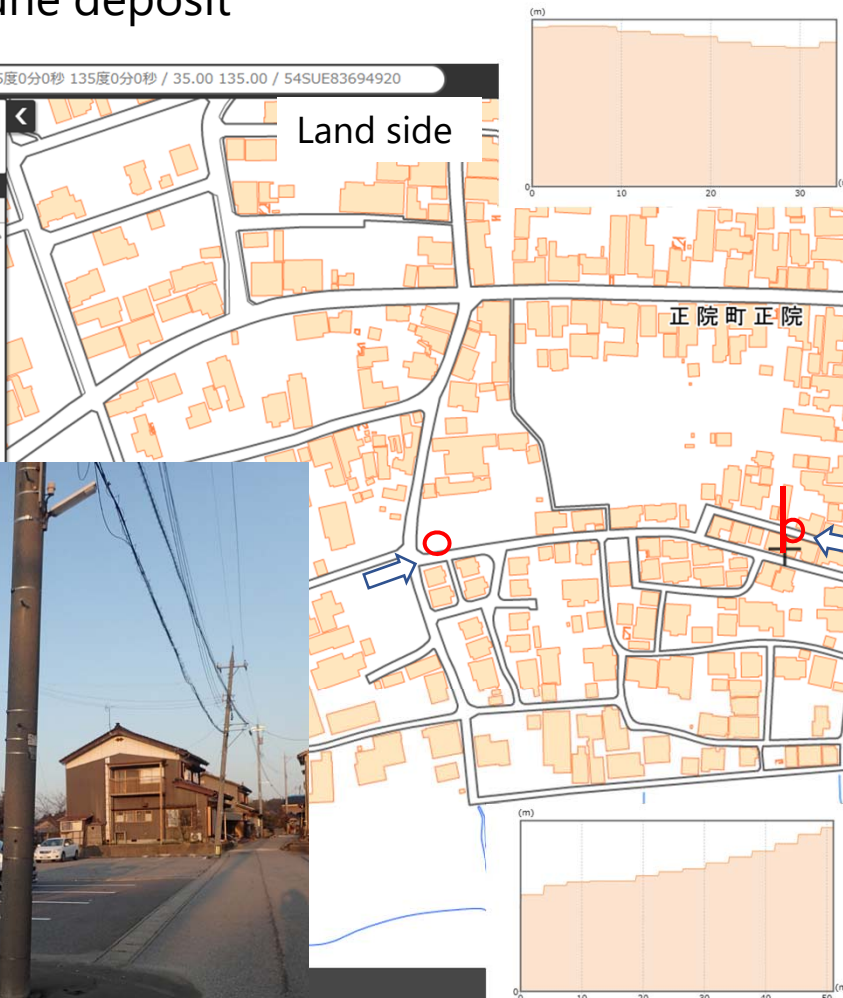
# Shoin

Lateral flow to the land side

Ave. gradient: 2% to land side

Ave. gradient: 3% to sea side

Ejected sand was reported during the 2007 Noto Peninsula Earthquake

Leaning manhole to the sea side

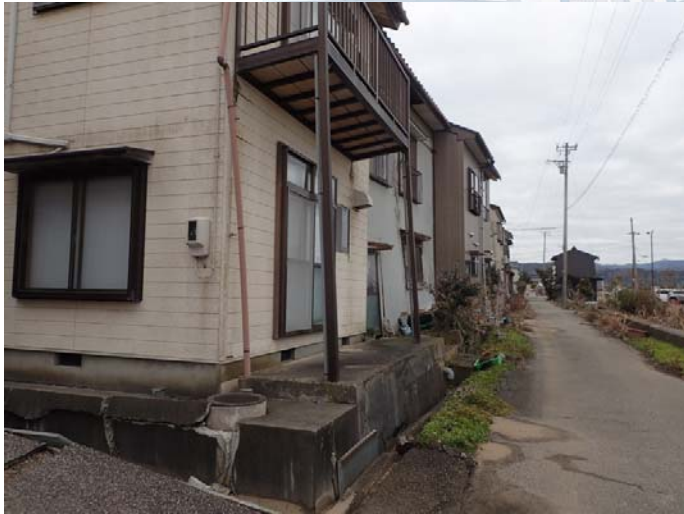
Severe liquefaction damage on residential house

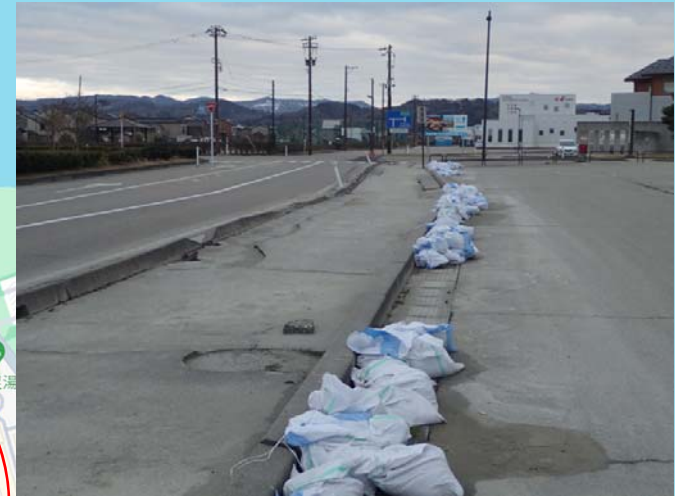
A lot of ejected sand in parking lot

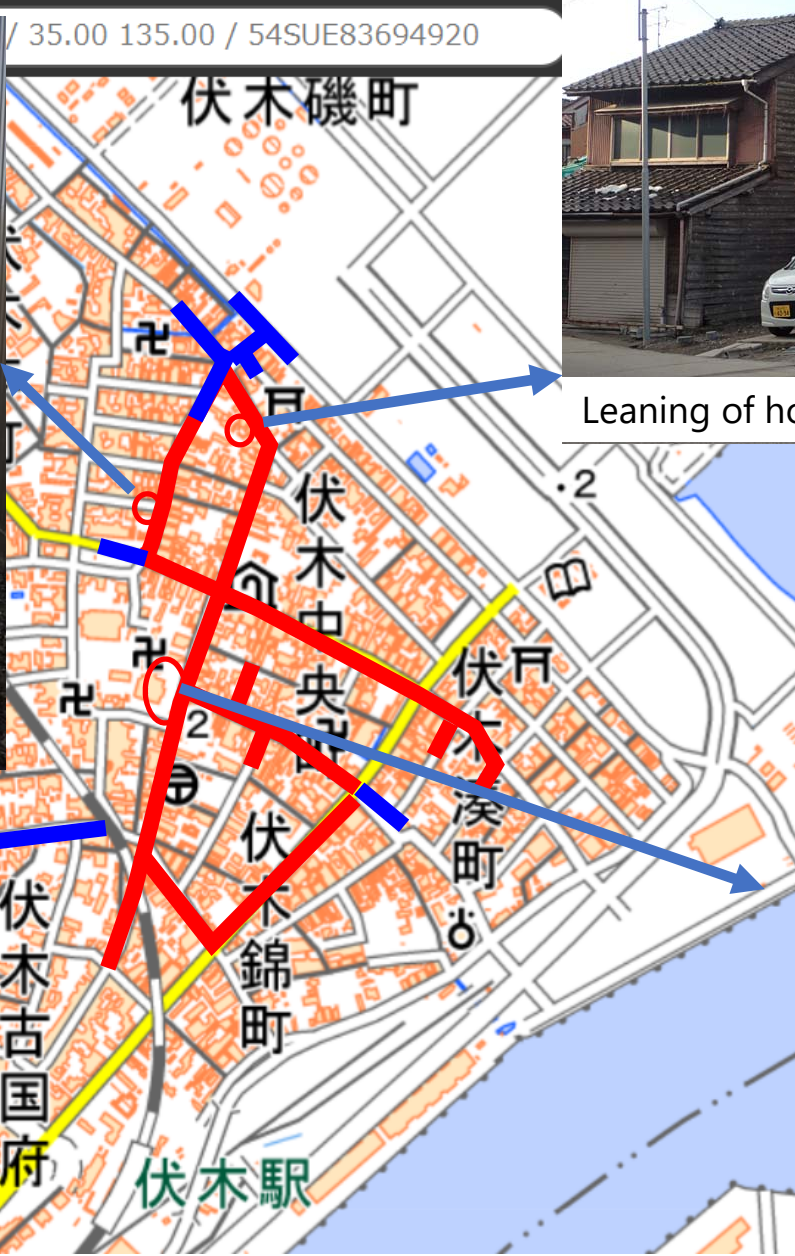
# Takaoka city

Leaning of house

Ejected sand

Liquefied area through the road

Settlement of side ditch

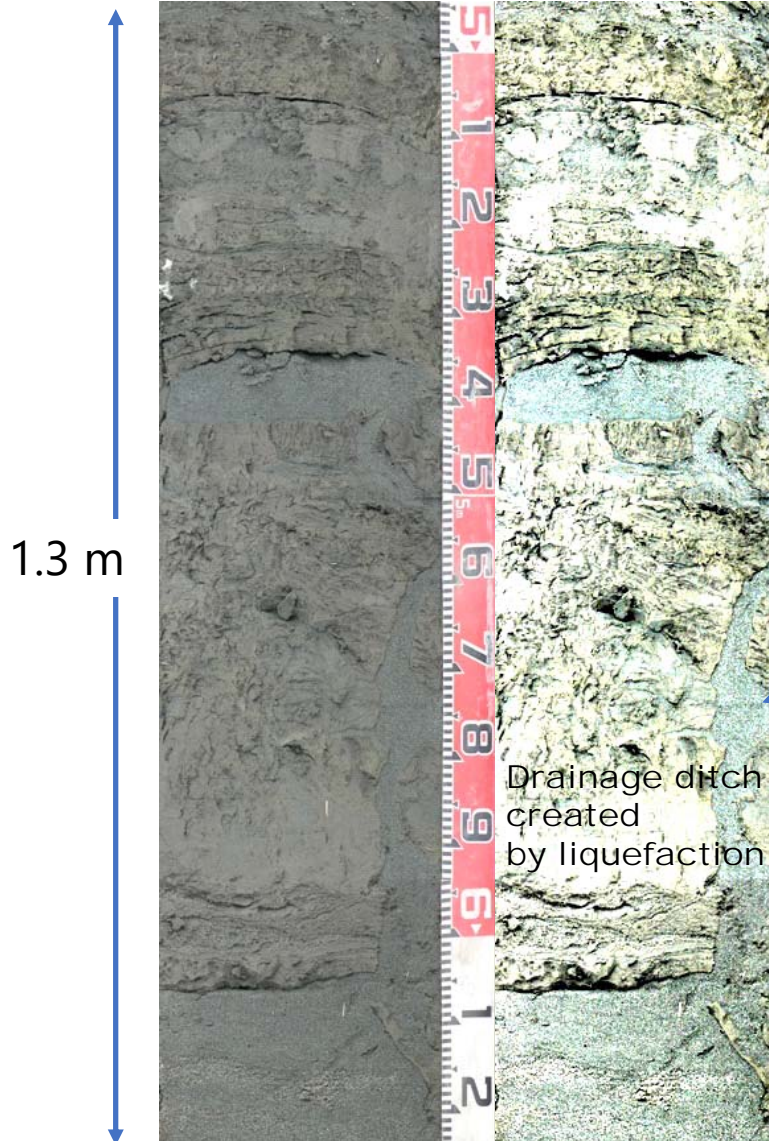
GS-2 (GL -5.0 to -6.3 m)

Drainage ditch  
created  
by liquefaction

Deeper layer than 5 m  
was also liquefied  
during the 1964  
Niigata Earthquake.

Inclined layers
