# The 2024 Noto Peninsula Earthquake

## - Liquefaction and lateral flow damage -

Hirofumi TOYOTA

Department of Civil and Environmental Engineering  
Nagaoka University of Technology

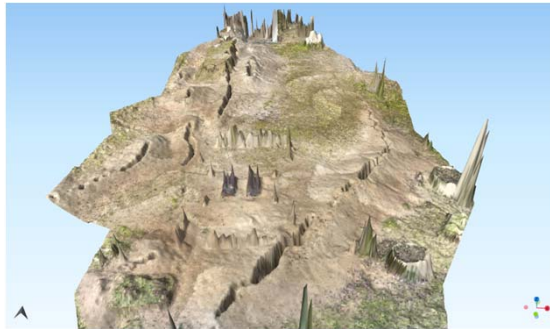
3D for open cracks (17<sup>th</sup> Jan.)

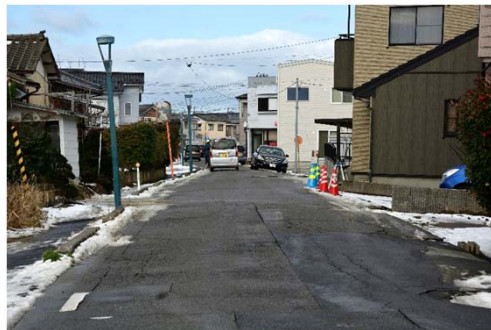
Upheaval of the road (3<sup>rd</sup> Jan.)

Uplift of 40-50 cm in the road

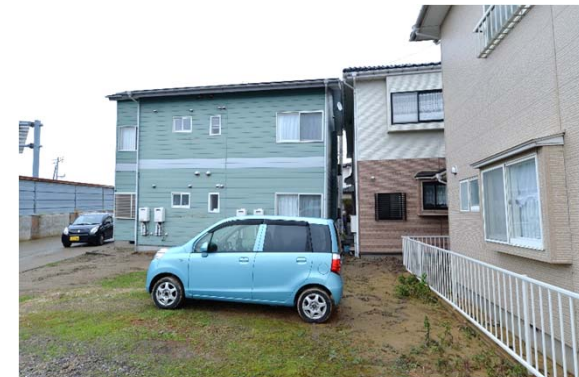
Leaning and settlement of the house (3<sup>rd</sup> Jan.)

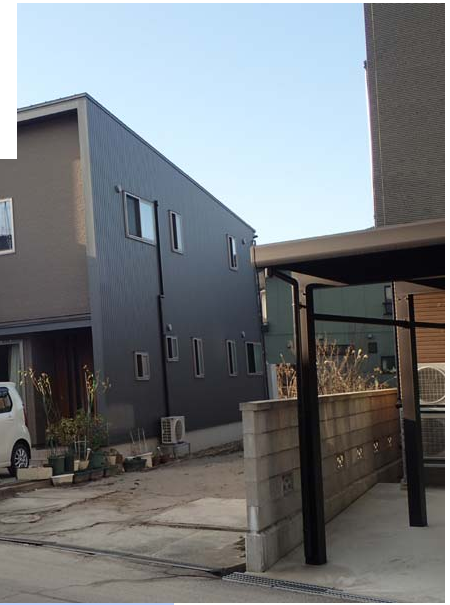
Leaning of house

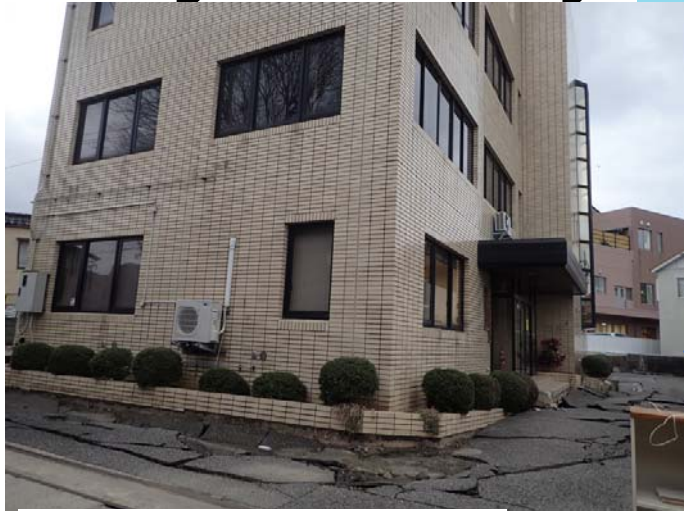
Leaning and settlement
