# The 2024 Noto Peninsula Earthquake

## - Liquefaction and lateral flow damage -

Hirofumi TOYOTA

Department of Civil and Environmental Engineering  
Nagaoka University of Technology

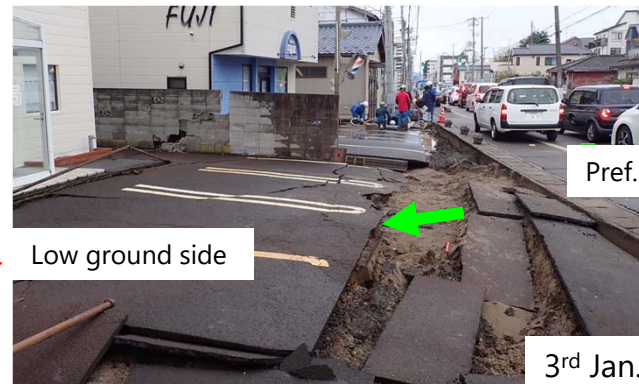
Average gradient: 50%

Deformation of the road is slight

Pref. road 16

Large flow and subsidence

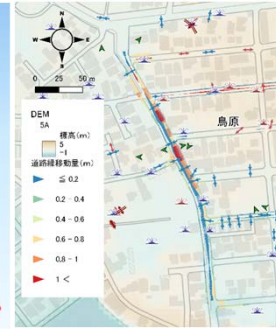
1 m-displacement

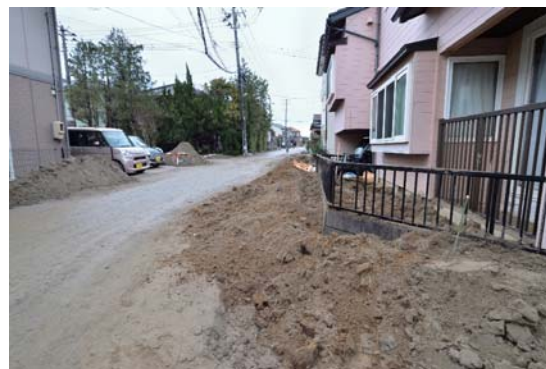
Ejected sand (3<sup>rd</sup> Jan.)

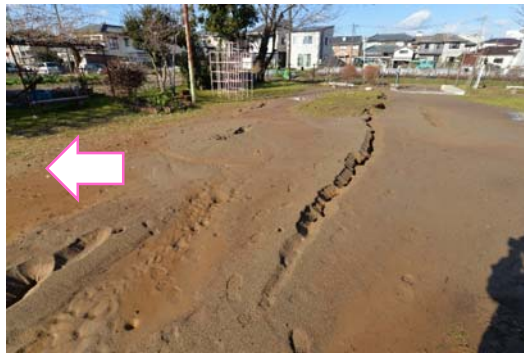
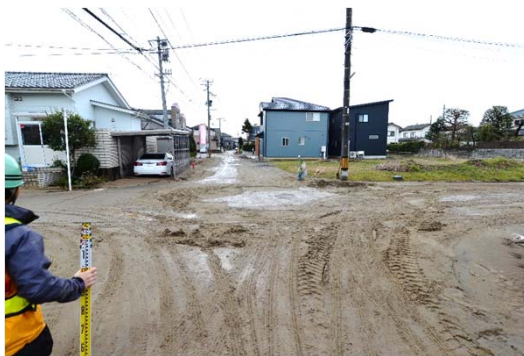
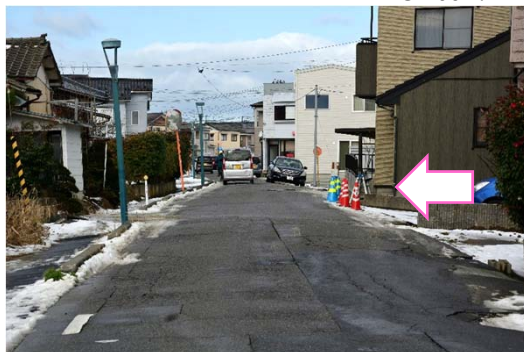
Lateral flow occurred in very gentle slope (1/200)

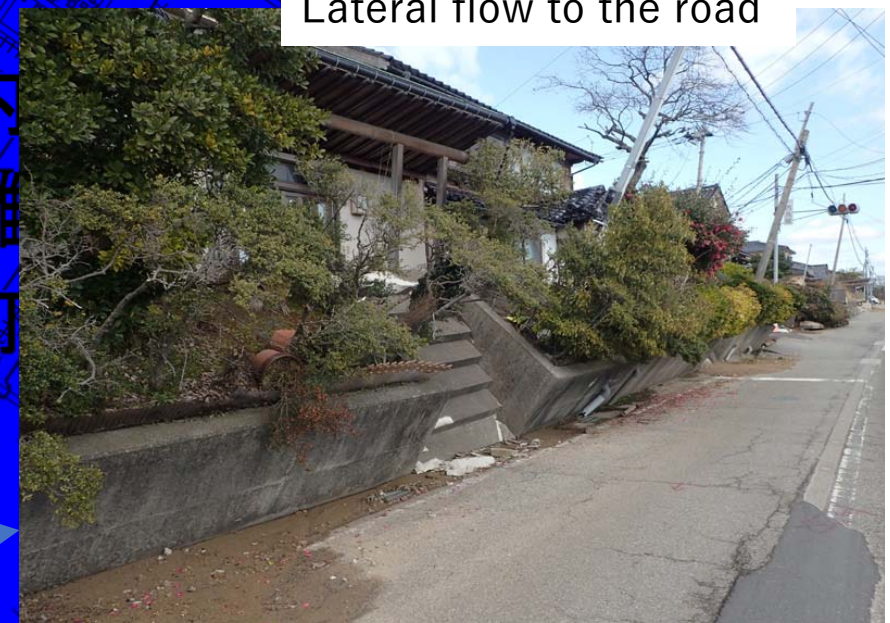
Lateral flow to the road

Spring water: high groundwater

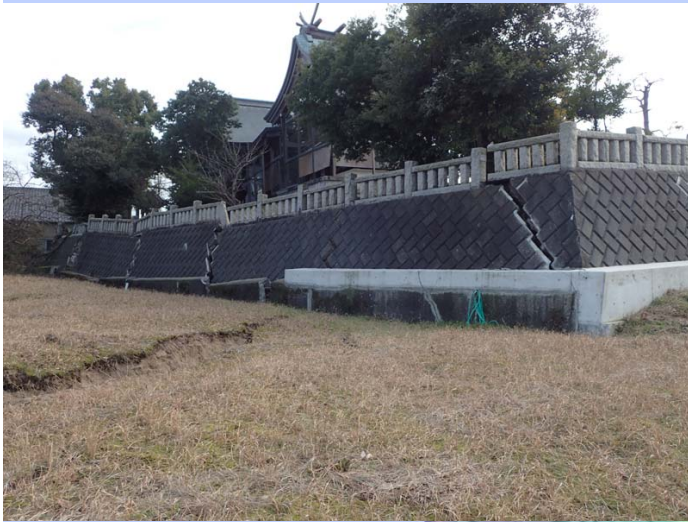
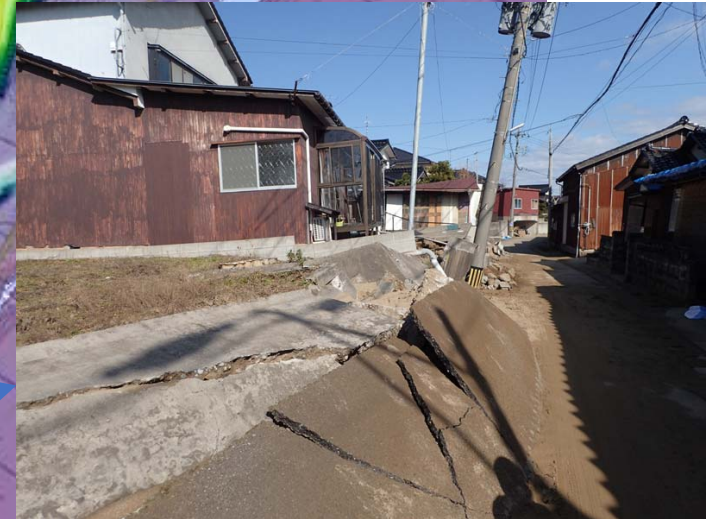
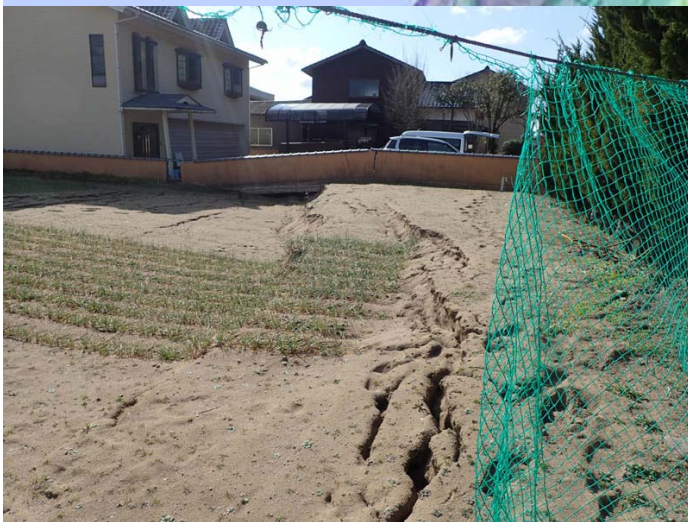
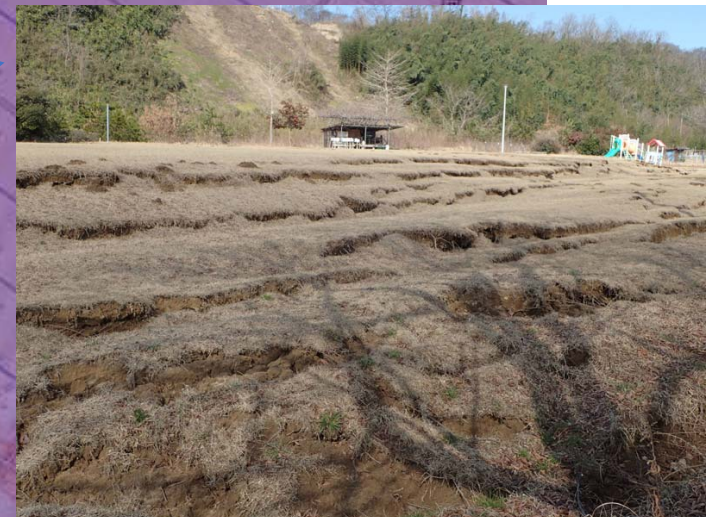
Nishiaraya

Damage inside the cutting dune

Expanding damage in flat ground

About 160 m inside from the road

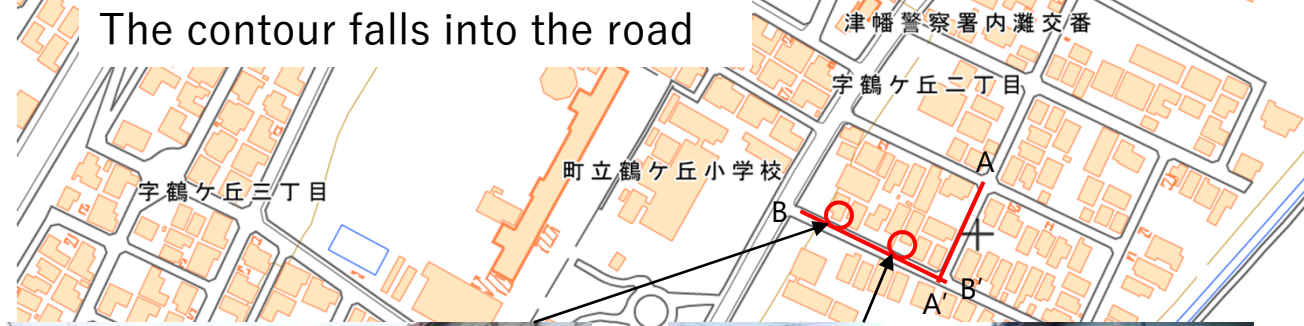
The contour falls into the road

Ave. gradient: about 1.3%

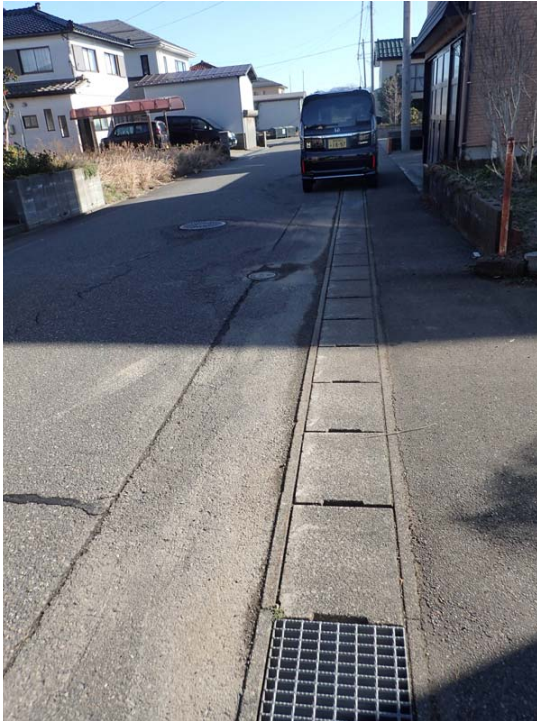
# Kashiwazaki-city

Ejected sand

Testimony: Sand was removed. A lot of water sprang out from the ground.

This place was liquefied at the 2004 Chuetsu and the 2007 Off Chuetsu Earthquakes

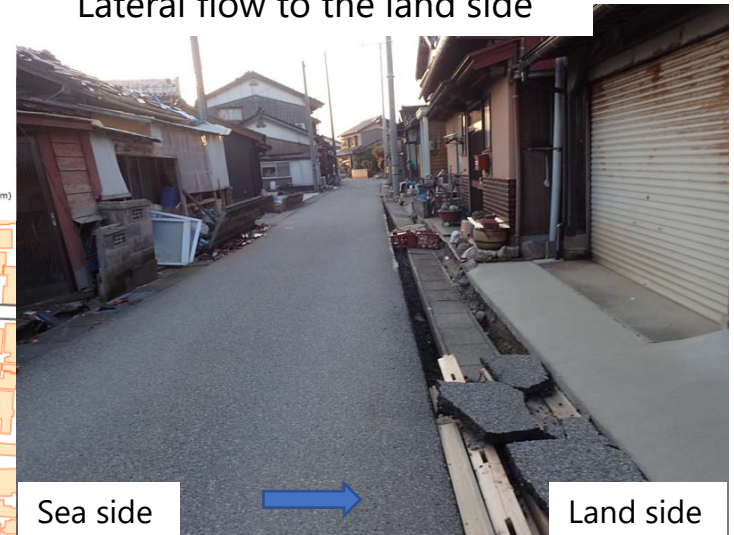
# Shoin

Lateral flow to the land side

Ave. gradient: 2% to land side

Ave. gradient: 3% to sea side

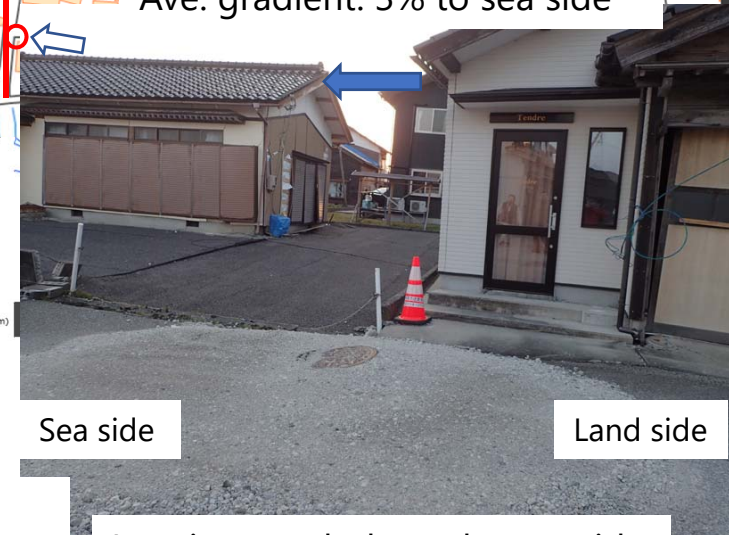
Leaning manhole to the sea side

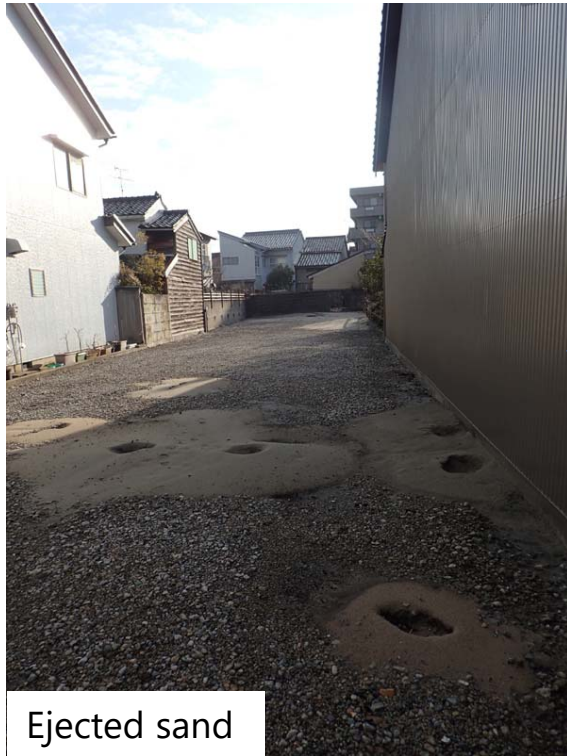
Ejected sand

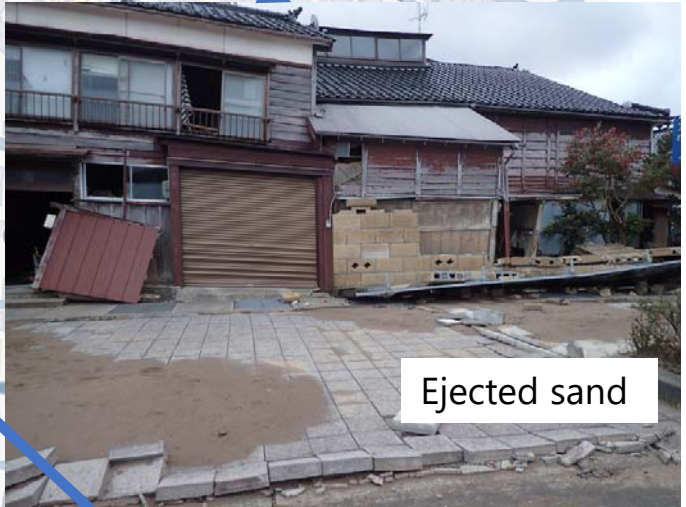
Ejected sand

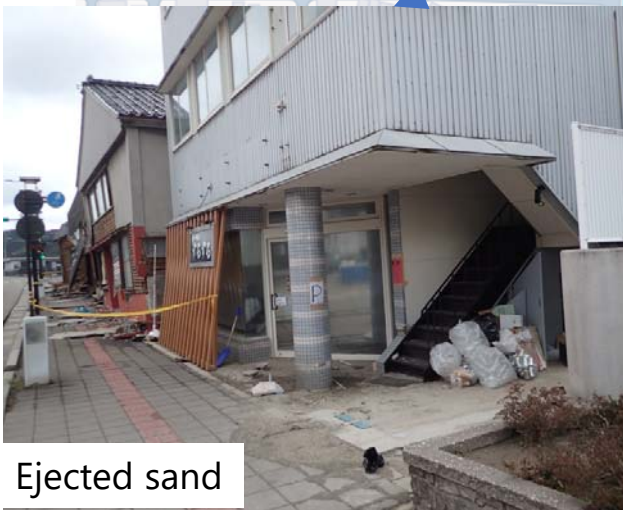
Ejected sand

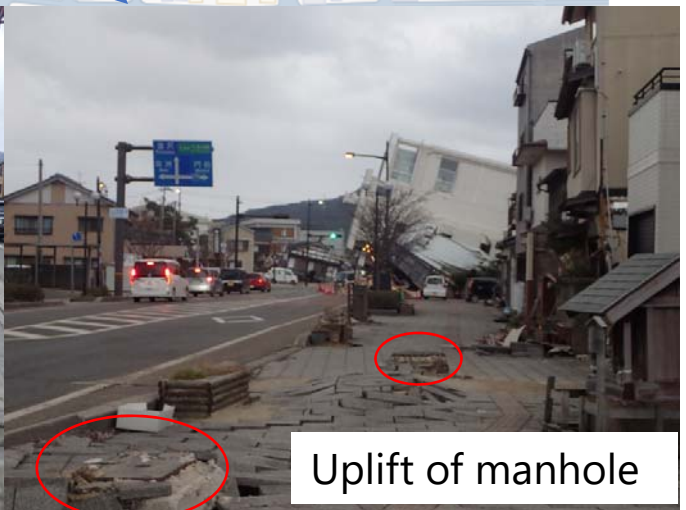
Uplift of manhole

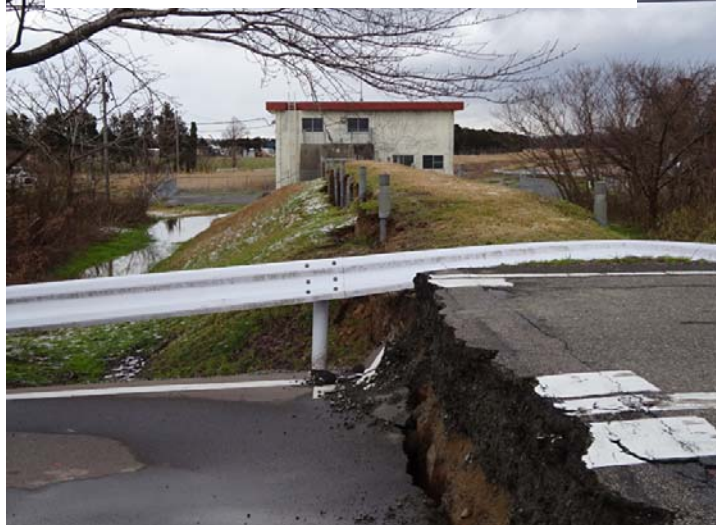
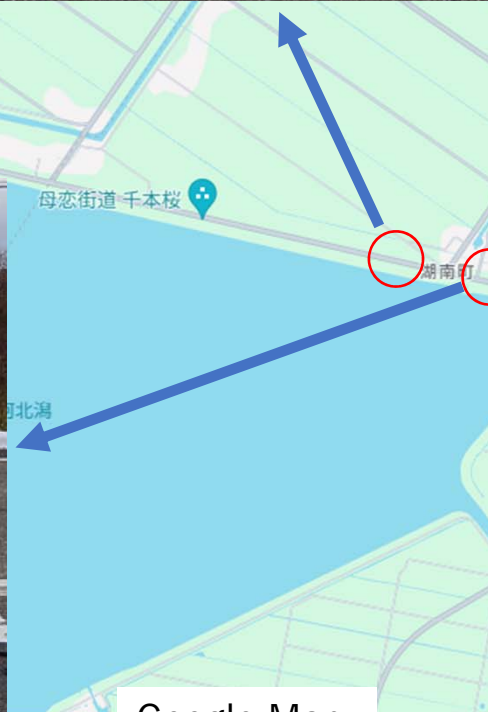
Level difference in levee and road

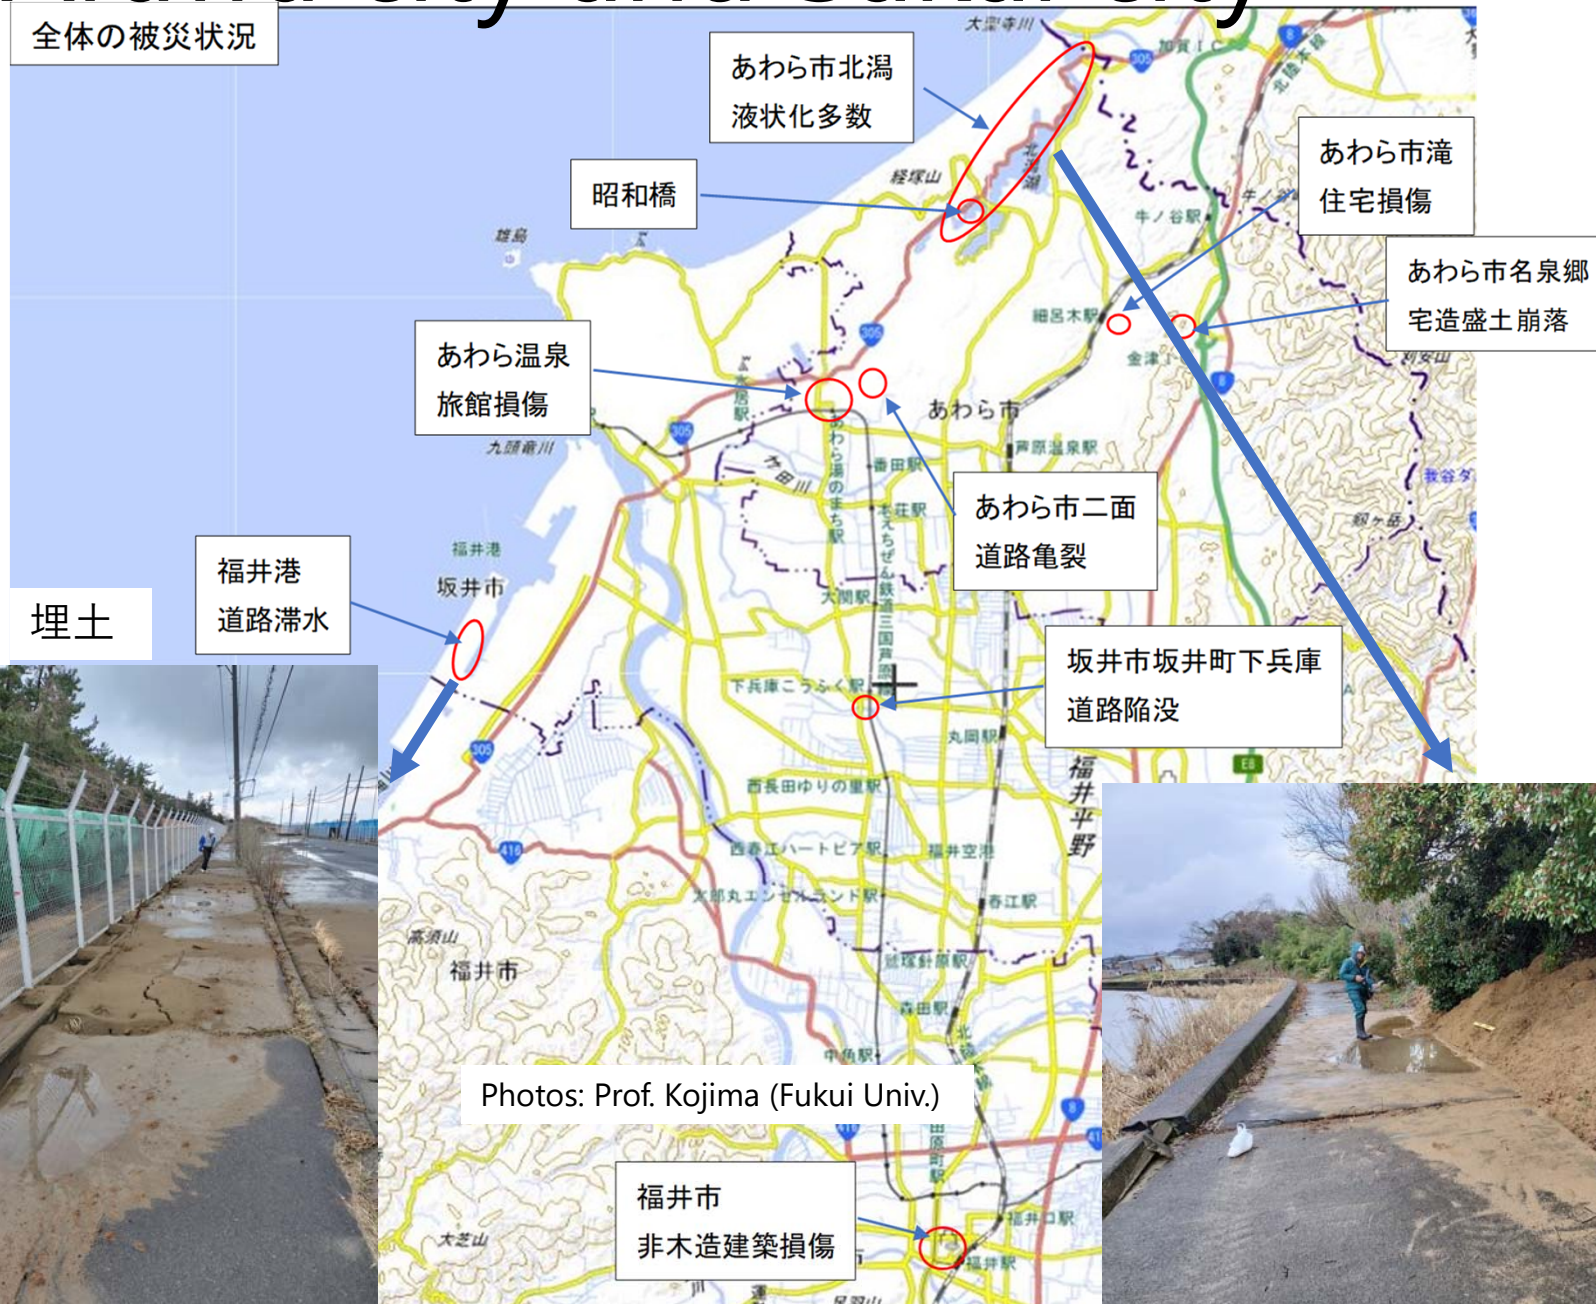
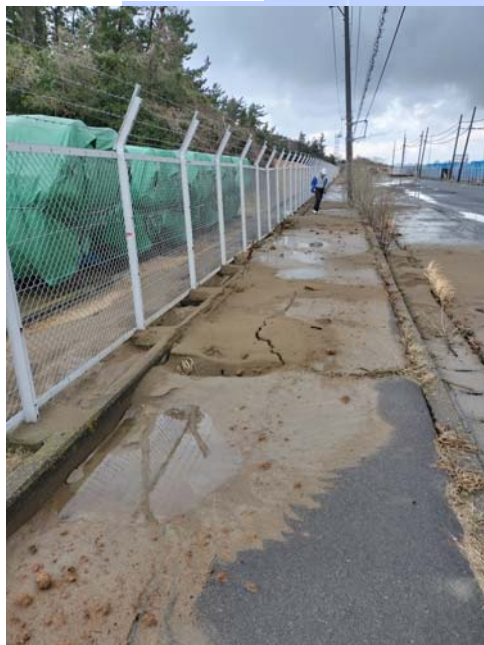
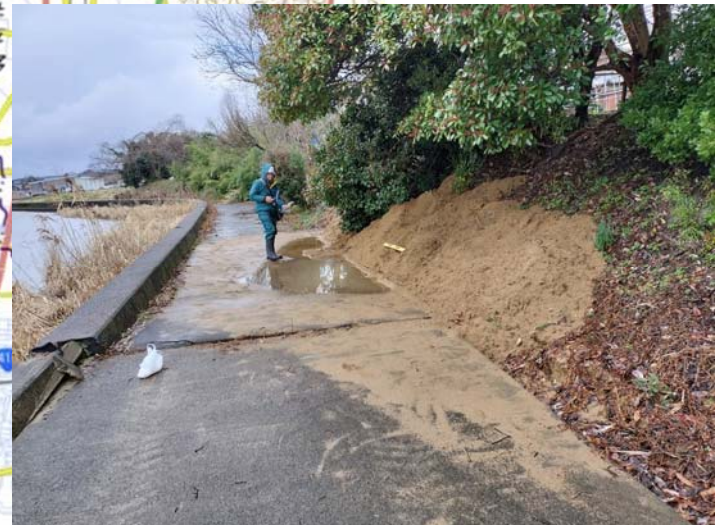
全体の被災状況
